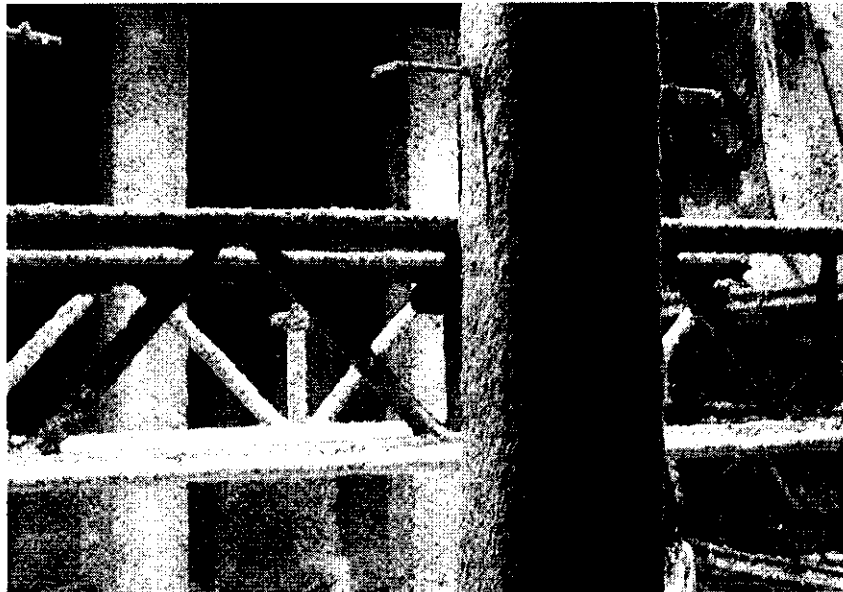
experienced applicator, who took considerable care to apply an even coating of the specified thickness. As such, the insulated test subjects represent a best case in terms of thickness and uniformity. Figure 6-42 shows some of the coated components.

Figure 6-42. SFRM-coated steel components prior to a test.

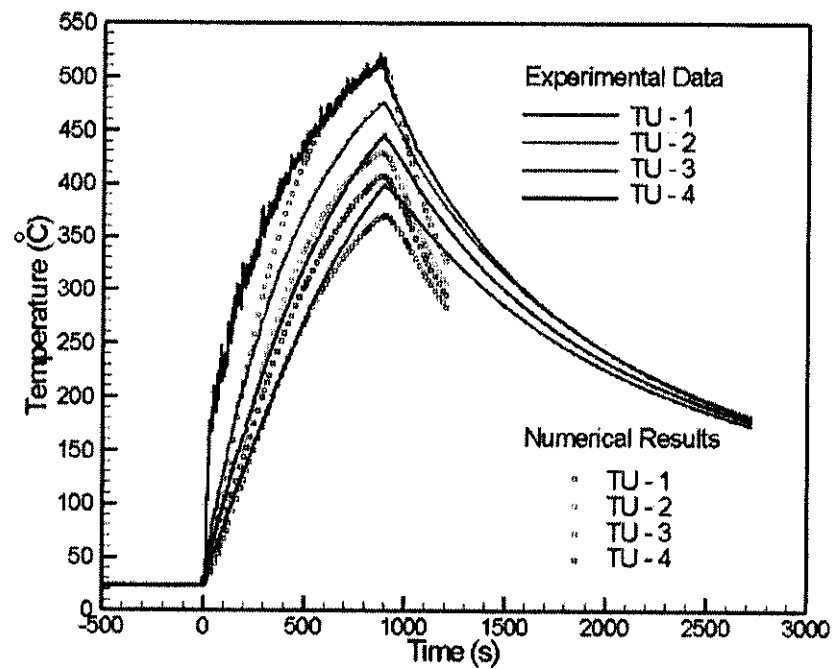
Figure 6–44 compares the measured and predicted temperatures on the steel surface of the top chord of a bare truss. Figure 6–45 is the analogous plot of the measured and predicted temperatures on the steel surface of the top chord of a truss insulated with 3/4 in. of BLAZE-SHIELD DC/F. Similar curves were generated for each of the steel pieces, bare and insulated.

Figure 6-44. Comparison of numerical simulations with measurements for the steel surface temperature at four locations on the top chord of a bare truss.

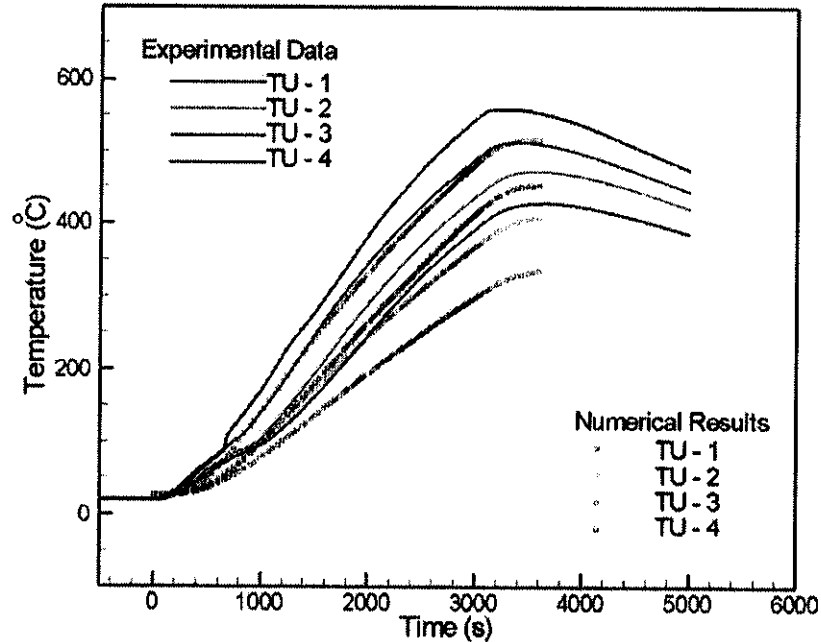
Figure 6-45. Comparison of numerical simulations with measurements for the temperature of the steel surface at four locations on the top chord of an insulated truss.

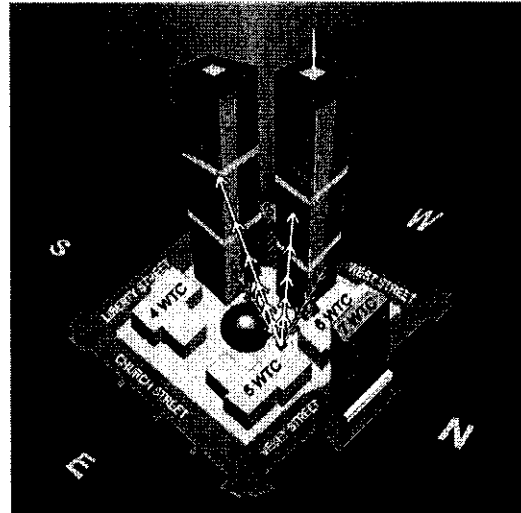
- Established a PAPD Command Center inside of WTC 5.
- Installed Fire Command Desks in the lobbies of WTC 1 and WTC 2.
- Installed in WTC 5 a radio repeater that operated on the FDNY city-wide high-rise frequency. (The radio repeater's function was to receive FDNY radio communication on a specified radio frequency, amplify the signal power, and retransmit the radio communications on another specified radio frequency that the FDNY radios could receive. This could enhance communications in buildings made of steel and reinforced concrete that pose challenges to radio-frequency communication.) The antenna was located on the top of WTC 5 and was directed at WTC 1 and WTC 2 (Figure 7-5). On September 11, 2001, the controls for operating the repeater were located at the Fire Command Desks in the tower lobbies.

Figure 7-5. Location of the radio repeater.

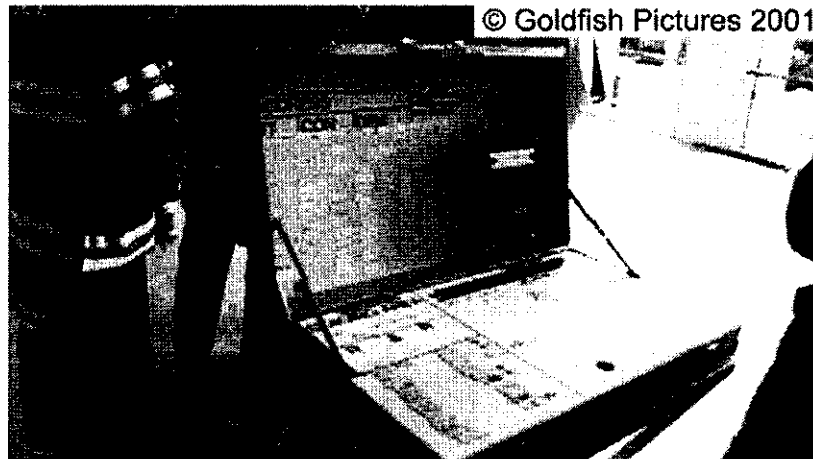
Figure 7–7. Fire Command Board located in the lobby of WTC 1.
